Subject: Fastening Bolts for Accessory Case

Affected engine models: All engine models

LIMBACH L 2000 DA

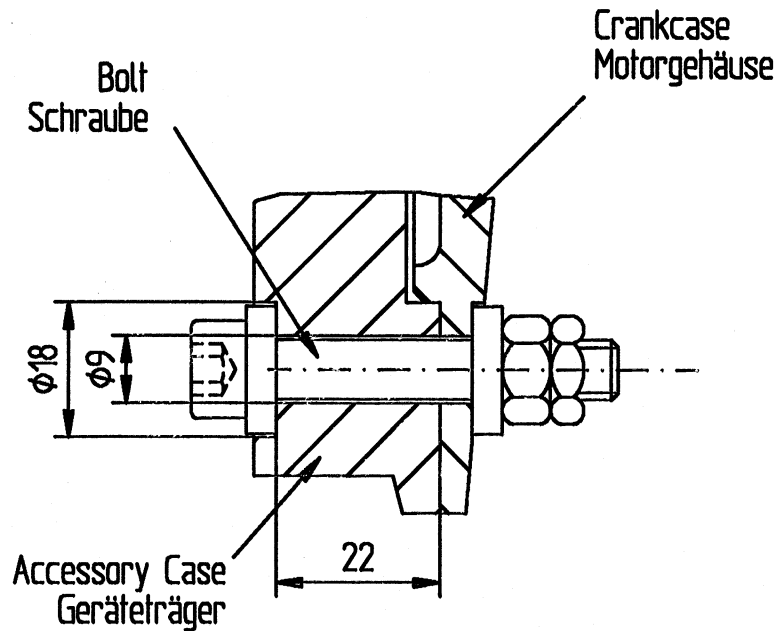
Fig. 1. Fastening of accessory case (detail)

On engines of the abovementioned series, the bolts for fastening the accessory case have turned loose in a single incident. The symptom was traced back to setting of the materials involved, due to too high pressure underneath the bolt heads and due to paint on the mating surfaces between accessory case and engine crankcase.

1. Remove engine.
2. Disassemble accessory case.
3. Enlarge the countersinks for the bolts from 15 mm to 18 mm with a spot facer having a 9 mm pilot until the surface for the washer is uniform, but not deeper than 22 mm measured from the mating surface of the crankcase (see Fig.).

4. Remove paint from the mating surfaces between accessory case and crankcase.
5. Insert new O-Ring P/N 170.122.100 at the crankcase flange.

6. Reassemble accessory case. Use the following materials:

- Allen head bolt M8*50, strength class 12.9 (black coating)
P/N 205.111.670 - 4 ea.
- Washer 8,5*17,5*4 P/N 205.039.015 - 8 ea.
- Hex nut M8 strength class 10 (black coating) P/N 205.111.660
- Safety nut M8 P/N 520.011.008

Torque nuts to 39 Nm.
