**Subject:** Throttle Lever Spring

**Affected engine models:** All engine models:

**L 2400 EF, DF,  
L 2400 ET, DT**

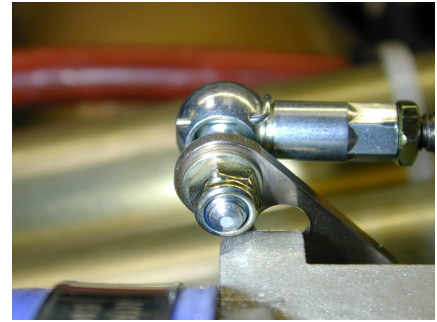
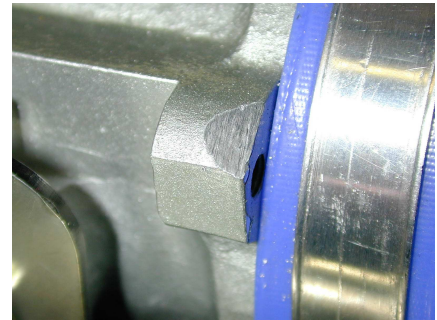
Check the throttle lever for freedom of movement. The locknut may collide with the intake manifold if the lever is rested against its left stop (in direction of flight).

Install the stepwasher onto the ball head and insert both parts into the second hole (counted from the shaft). From the rear install and tighten a washer and a locknut.

In such cases use a file to remove metal from the fastening lug until there is a gap of at least 1mm between the locknut and the intake manifold.

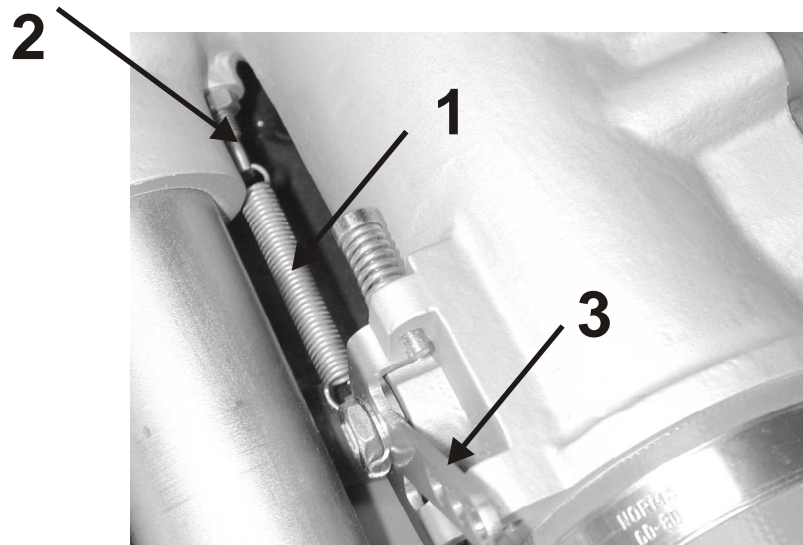
Fig. 2

On engines that were not yet modified according to TB 67 (Fig. 2) the old spring (1) must be removed also.

- After removing the spring (1) the spring hanger (2) can remain at the engine.

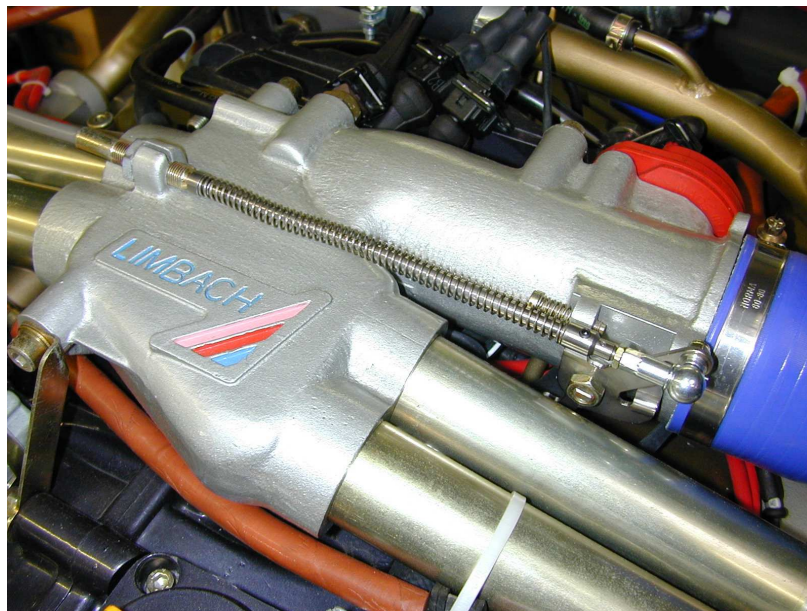
***New Condition***

**Compliance:** The assembly kit used according to TB 67 (Fig.1) must be removed and replaced by an assembly kit according to Fig. 3

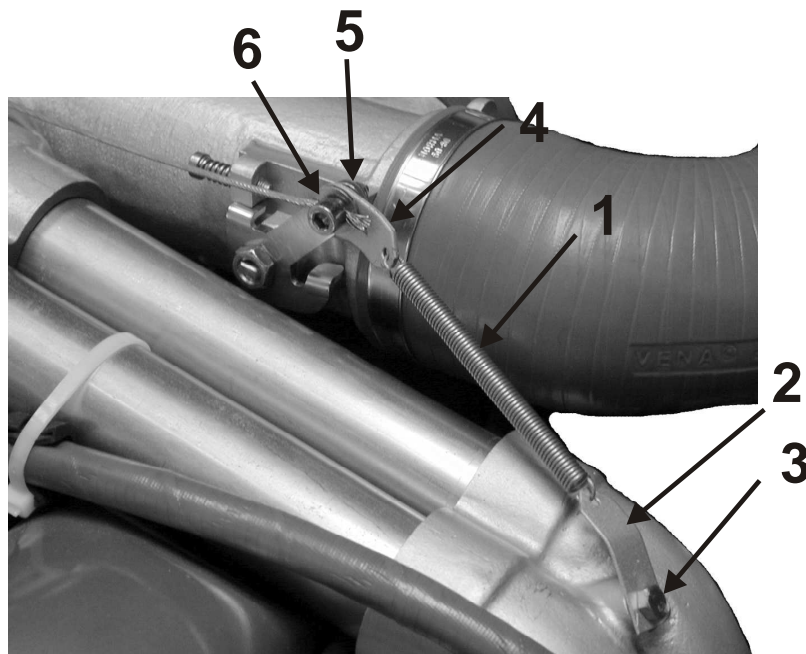
Fig. 1

**Background information:** Broken throttle lever spring in several cases. In the worst case the throttle lever can get stuck with the broken spring and prevent the operation of the throttle. With a blocked throttle lever it is not possible to change the set power output and adjust the performance. Therefore unsafe flying conditions can occur.

**Old Condition:**
